# The bomb in your backyard

## Exploding pool filters

BY ANTHONY LABEL  
*The Veen Firm, PC*

BY OLIVER VALLEJO  
*The Vallejo Law Office*

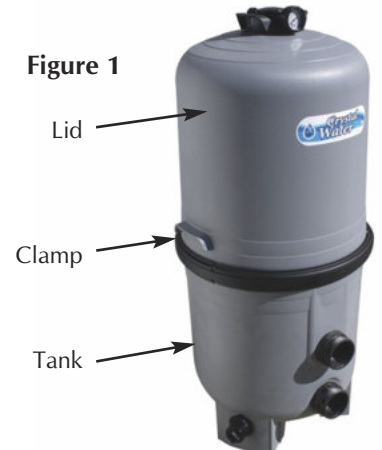
Most filters are comprised of a tank, a lid, and a clamp that holds the system together (Figure 1). The filter operates under high pressure generated by a mixture of water and air. The lid can explode off the tank with tremendous force if too much pressure builds up and the clamp fails.

An inferior fastener such as a clamp (Figure 1 on page 37) can bend, break or degrade, and allow the filter lid to blow off with tremendous force. For example, in 2004, the CPSC recalled 8,500 pool filters because the filters’ fastener “can disengage from the lower tank shell allowing the top shell of the filter to blow off causing injury to nearby consumers.”

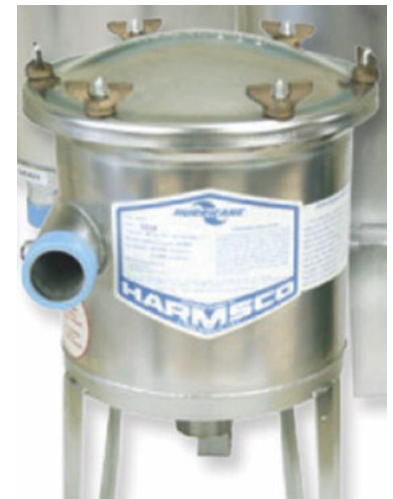
Figure 4

Lugs and nuts are technically feasible, economically practical and safer than a clamp. Competitor filter manufacturers have used the design in Figure 4.

A safe system would have multiple lug and bolt clamps to create multiple redundancies and eliminate the chance of explosion or sudden separation.

Lugs and nuts would eliminate the risk of serious injury. When a lug or nut fails, the remaining lugs and nuts hold the lid and bottom together. At worst, a failure of one nut would cause water to leak from the filter. A manufacturer's PMQ will likely testify that there were no technological impediments to a nuts-and-bolts system.
